**NUMBER: 390120003.01****MODEL: Karma****DATE: January 20, 2012****MODEL YEAR: 2012****TITLE: Baseline 613 Release Overview****PRIORITY:**

Flash reprogramming allows the ECU software to be updated without replacing the ECU. Flash calibration updates for specific vehicle models/ECUs are released as field-fix procedures described in individual service bulletins.

This Campaign will be used as a reference guide for technicians to update a vehicle to Baseline 613 by listing software ID numbers as well as the required flash files necessary to update an ECU. A baseline update may only require that certain ECUs to be updated. Using this guide, the technician can determine what ECUs have updates and those that do not require it.

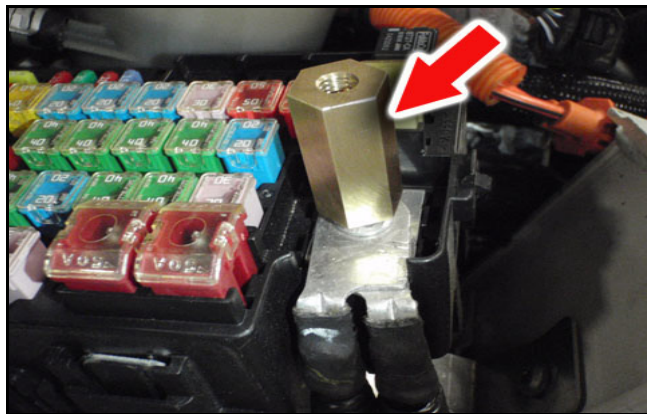
– If the low-voltage Battery is not at least 12.2 volts, you must charge battery. Connect the positive lead of the Midtronics MDX series tester (or equivalent) to the B+ positive post at the Power Distribution Center (PDC) with Fisker Special Tool **FST9001 – Battery Charging Terminal Adaptor** (to be used for all electrical system testing and charging). Connect the – Negative lead to the Accessory Power Module (APM) ground terminal.

FST9001 - Battery Charging Terminal Adaptor (red arrow) installed on the B+ post in the PDC.

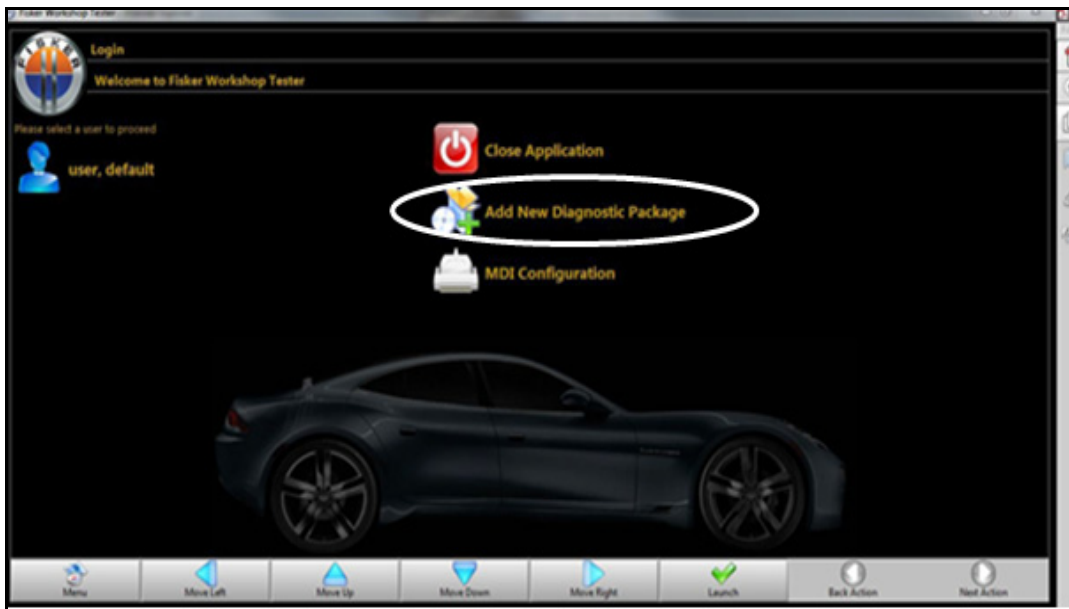
3c. Open the FiskerWT software. Update by clicking the “*Add New Diagnostic Package*” Icon from the main screen.

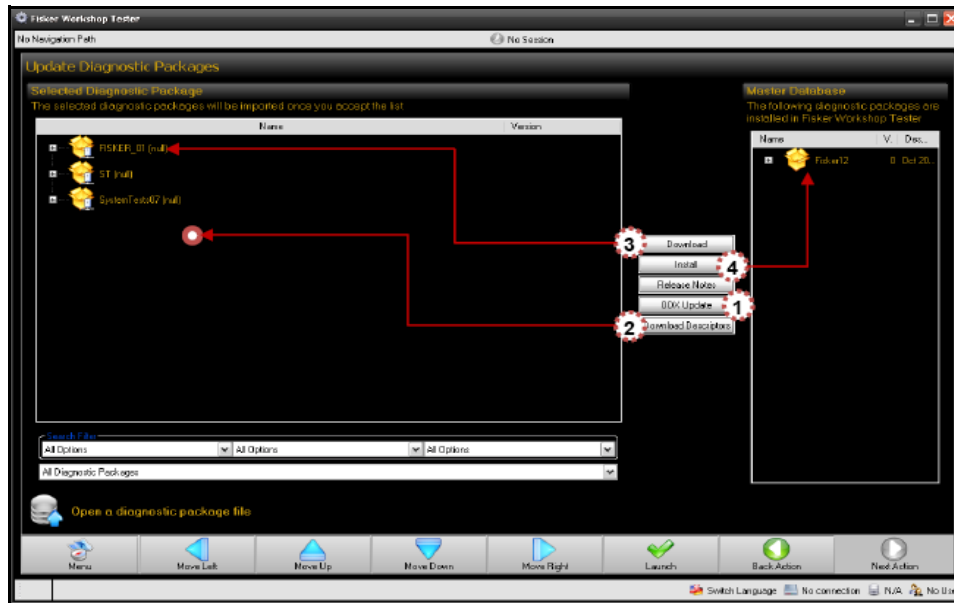
3g. After the download of the descriptor is complete, select the “Install” button or double click on the deliverable. As a result, the deliverable will be shown on the right hand side, indicating it is installed to the laptop.

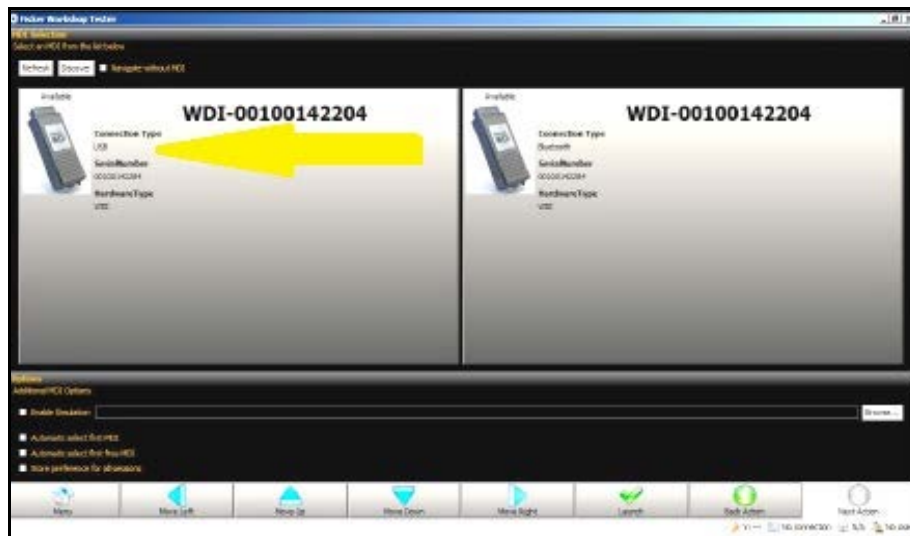
3j. Select WDI (Connection Type - USB) by clicking on it once. When the gray box turns green, the WDI is ready to use.

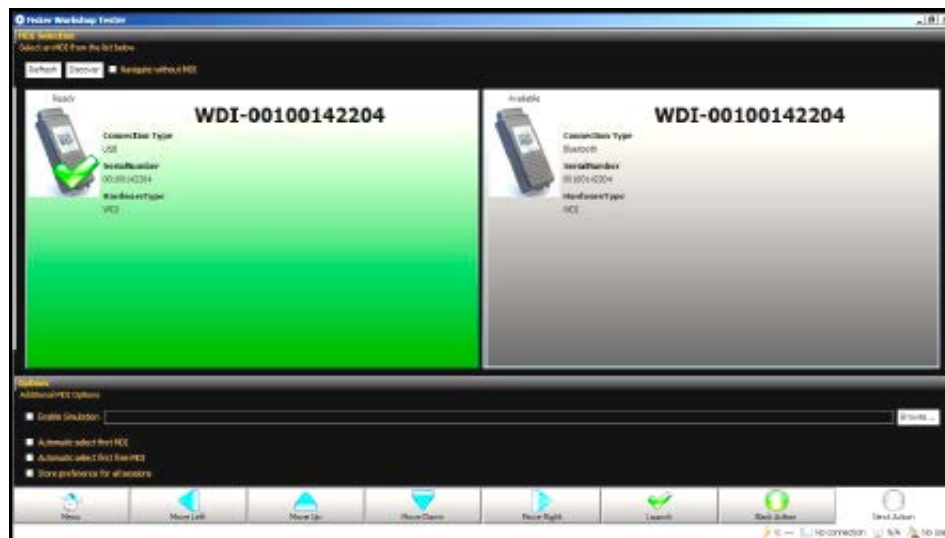
NOTE: There may be new firmware to install depending on when you have last connected. By selecting the WDI connected via the USB cable, any new firmware will install automatically. When the installation is complete, the MDI selection menu will refresh automatically.

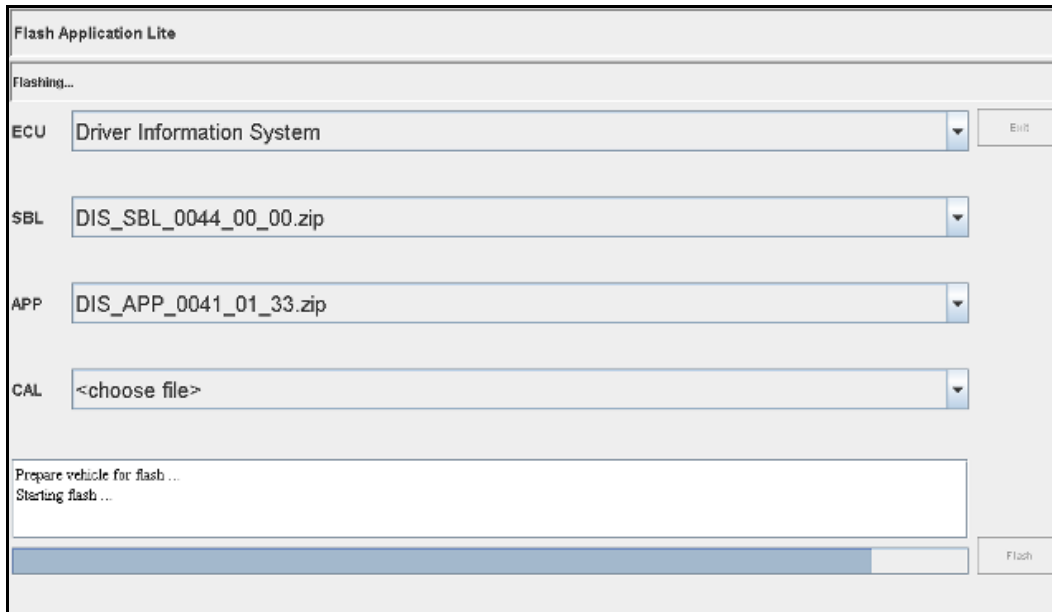
4f. After the vehicle has been flashed, verify that the Driver Information System ECU Software ID matches the Baseline 613 ECU ID chart on Page 3.

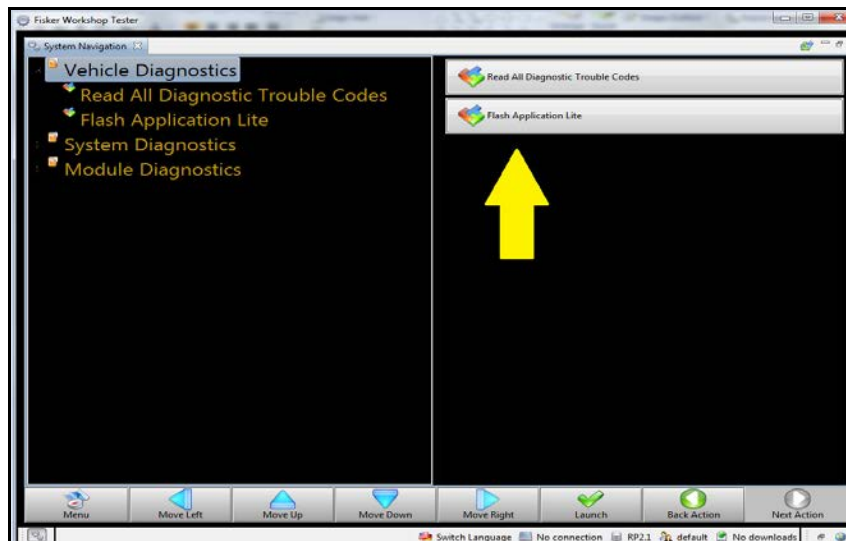
7a. After opening FiskerWT and entering the vehicle information; select Flash Application Lite in the System Navigation menu under Vehicle Diagnostics.
